INTERMOUNTAIN GENERATING STATION UNITS 1 & 2

HP TURBINE RETROFIT

Intermountain 2
End of Manufacturing Report

Name of Station INTERMOUNTAIN		Unit No: 1		S.T. No: T11246	
Title of Report HP TURBINE REPLANT			Report By W Falconer		
Summary					
<p>The unit was taken out of service on 1st March 2003 for a planned 28 day outage.</p> <p>Work included:-</p> <ul style="list-style-type: none"> • HP turbine rotor and inner shell (cylinder) replacement (upgrade) • IP turbine inspection • Steam admission valves inspection • Limited generator inspection and repair • Extensive boiler inspection and repair • Extensive boiler inspection and modification (upgrade) • Inspection and modification (upgrade) of various auxiliaries including boiler feed pump turbines and main CW cooling <p>This report describes the fitting of the new HP turbine rotor and inner shell.</p> <p>The turbine generator was resynchronised on 29th March 2003, and returned to commercial operation as scheduled.</p> <p>Formal performance tests were carried out during week commencing 7th April 2003. The results confirmed that the guaranteed efficiency had been exceeded.</p> <p>Stripdown and rebuild record sheets are contained in C

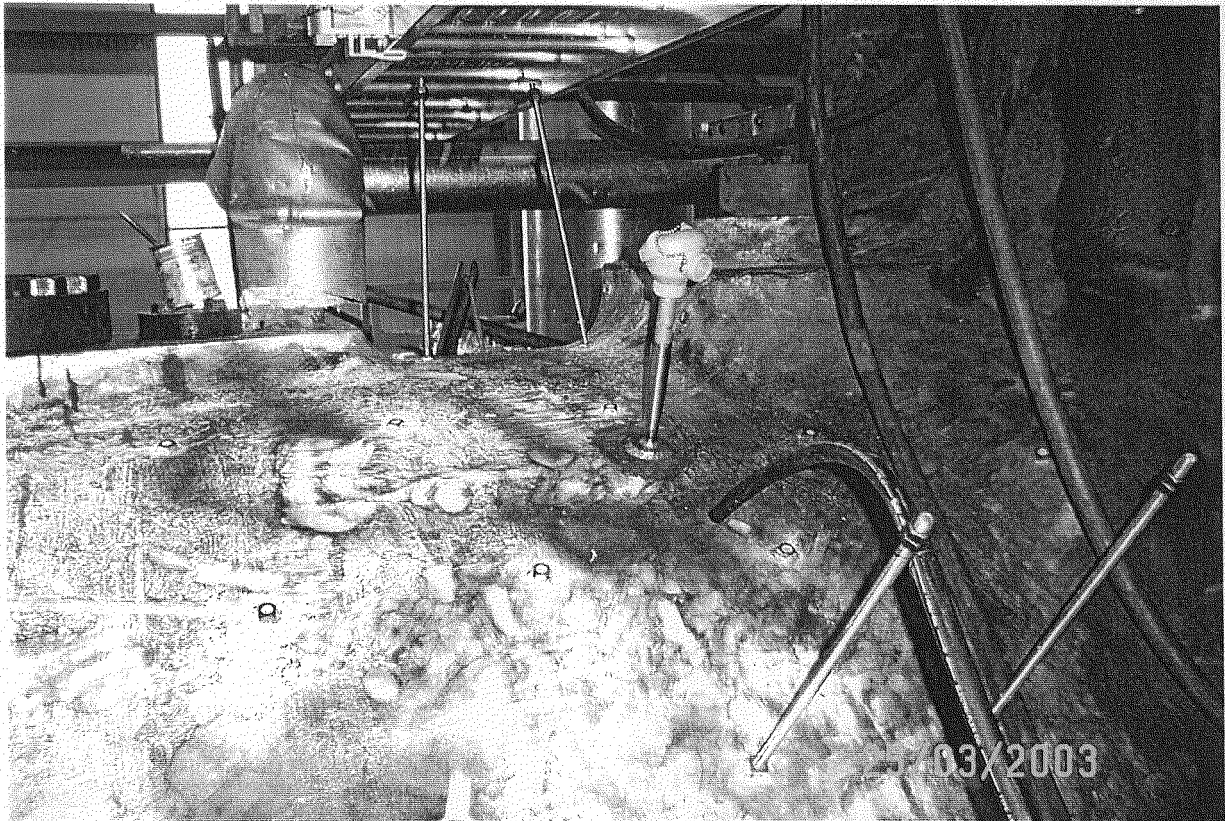
Photograph 11 – OUTER CYLINDER TOP HALF MID LENGTH THERMOCOUPLE

Thermocouples were fitted by IPSC to the outer casing to measure top to bottom temperature differential. These were attached to the outer skin at approximately mid length, and at an angle of approximately 10° to the vertical plane to avoid steam leak off connections. Photographs 11 and 12
